NASA CR-112119-2

**EVALUATION OF COATED COLUMBIUM ALLOY
HEAT SHIELDS FOR SPACE SHUTTLE
THERMAL PROTECTION SYSTEM APPLICATION**

PHASE II ♦ SUBSIZE HEAT SHIELD AND SMALL SIZE TPS EVALUATION

Prepared by
CONVAIR AEROSPACE DIVISION OF GENERAL DYNAMICS
San Diego, California

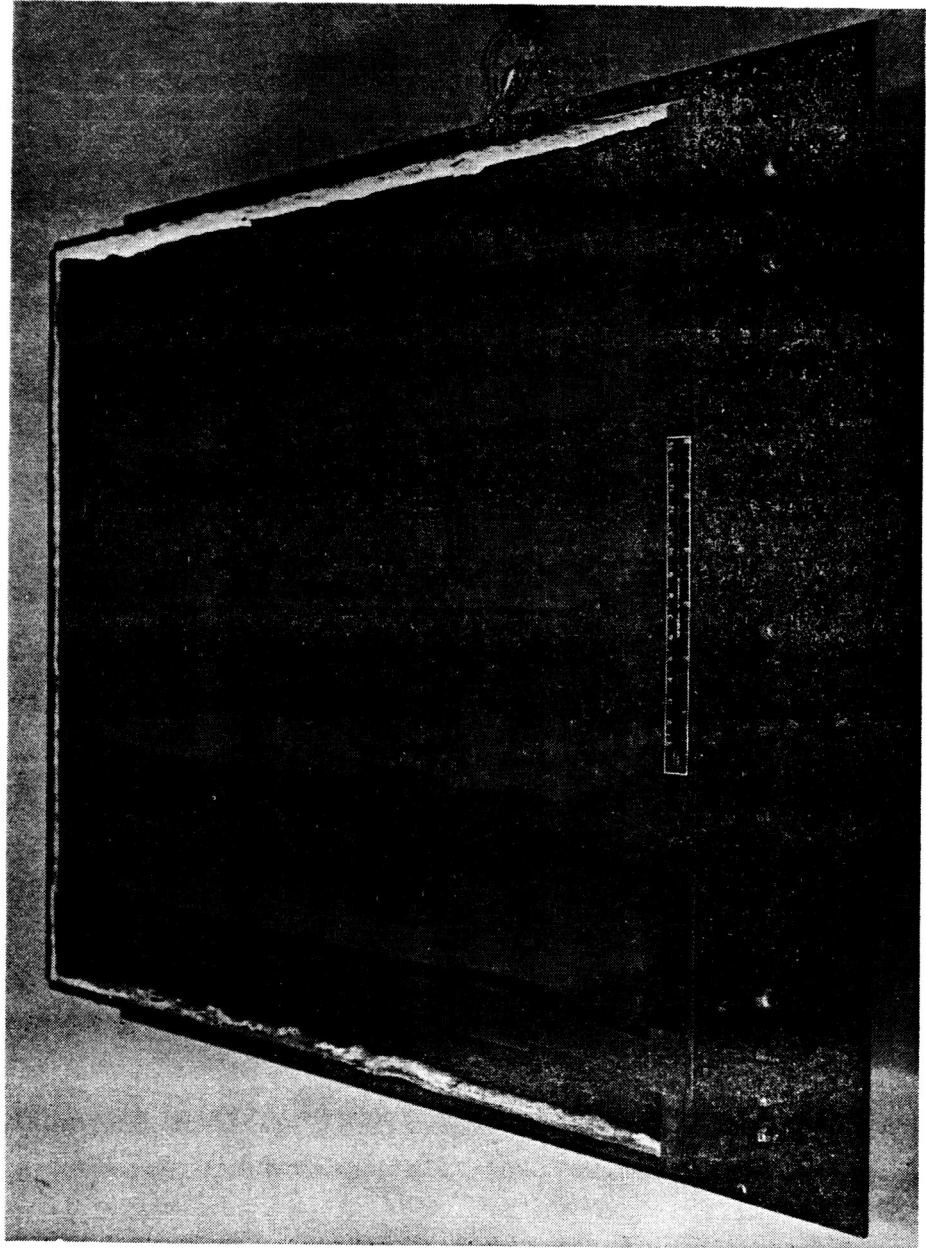
Figure 8-23. Open Corrugation TPS Specimen After 50 Radiant Heat/Pressure/Load Cycles — View Looking Downstream (Photo 133517B)

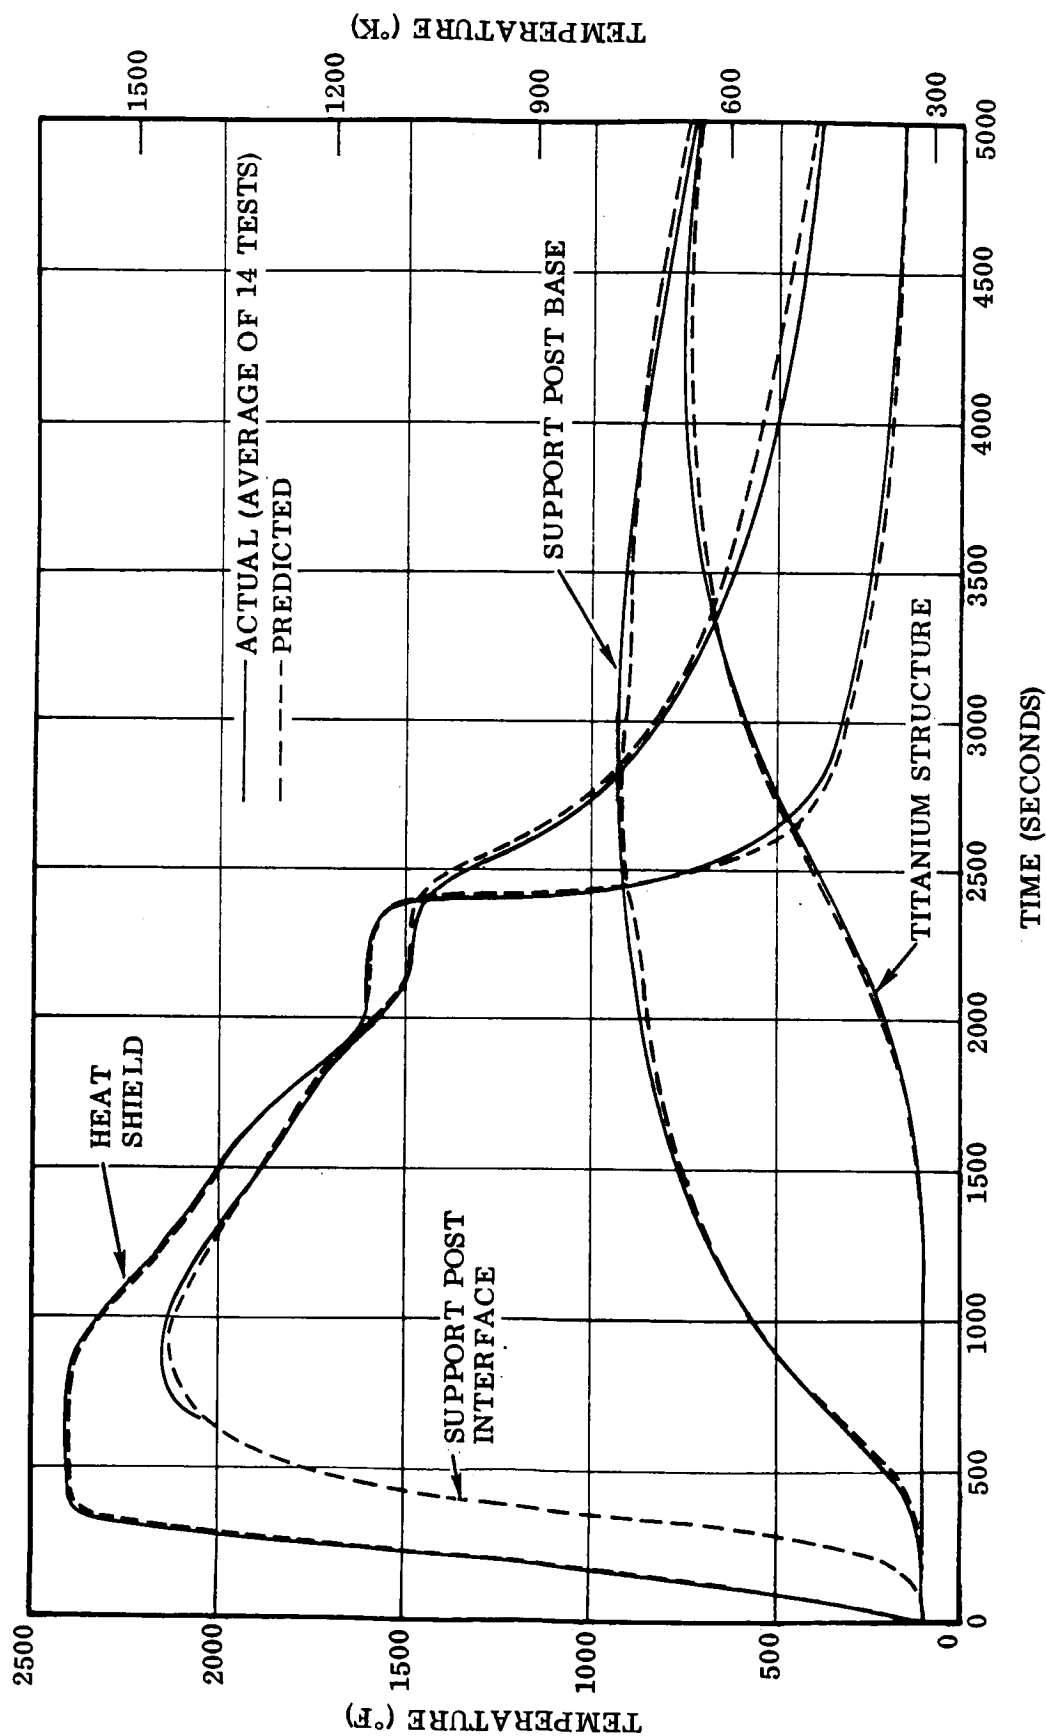
Figure 8-26. Radiant Heat Test Composite Temperature Distribution — Tee-Stiffened TPS

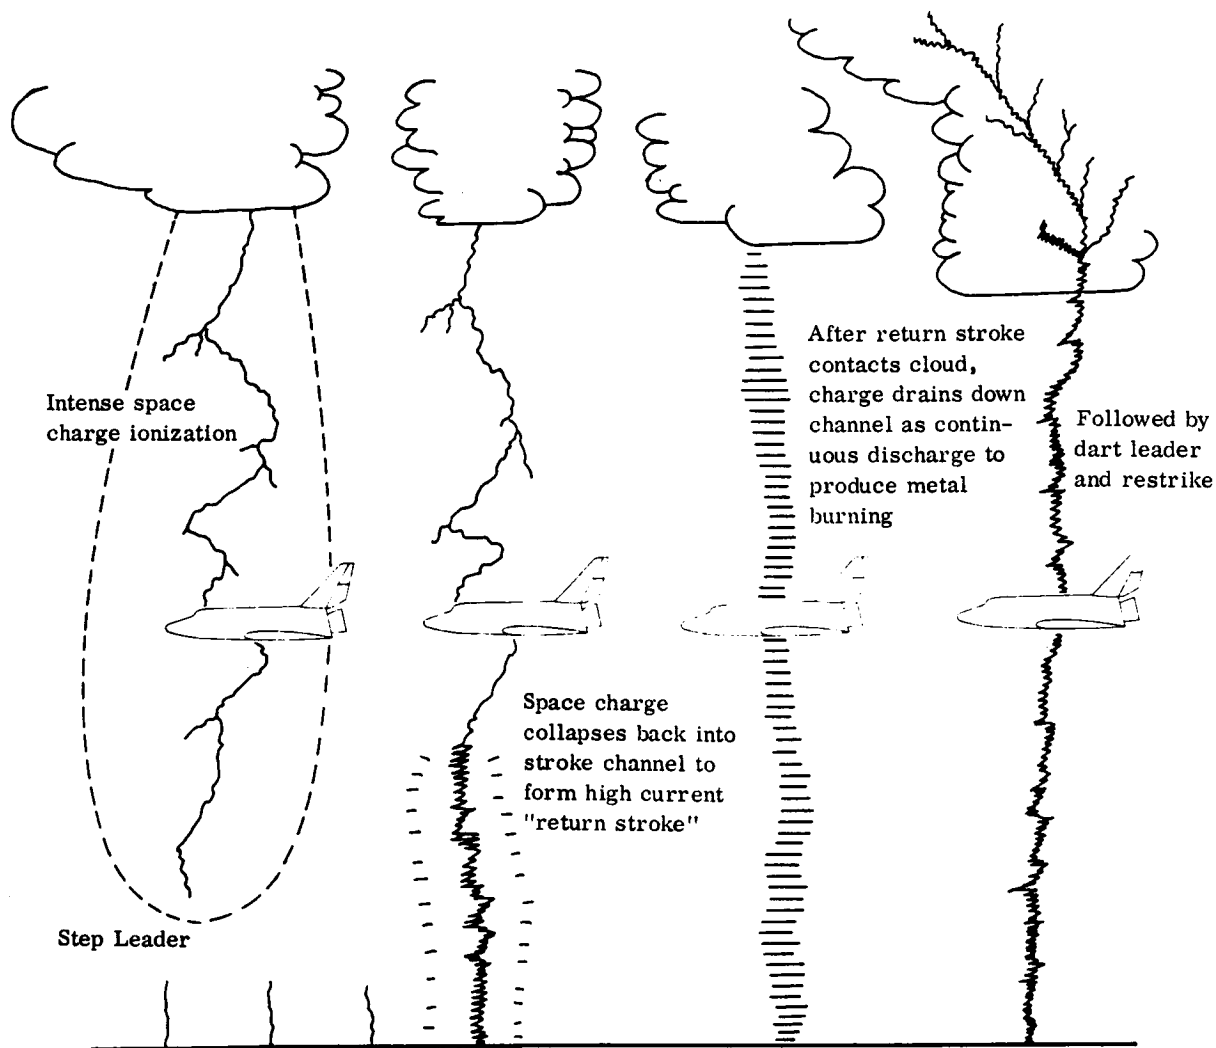
Figure 9-5. Illustration of Spacecraft Contact Mechanism and Movement Through Lightning Channel

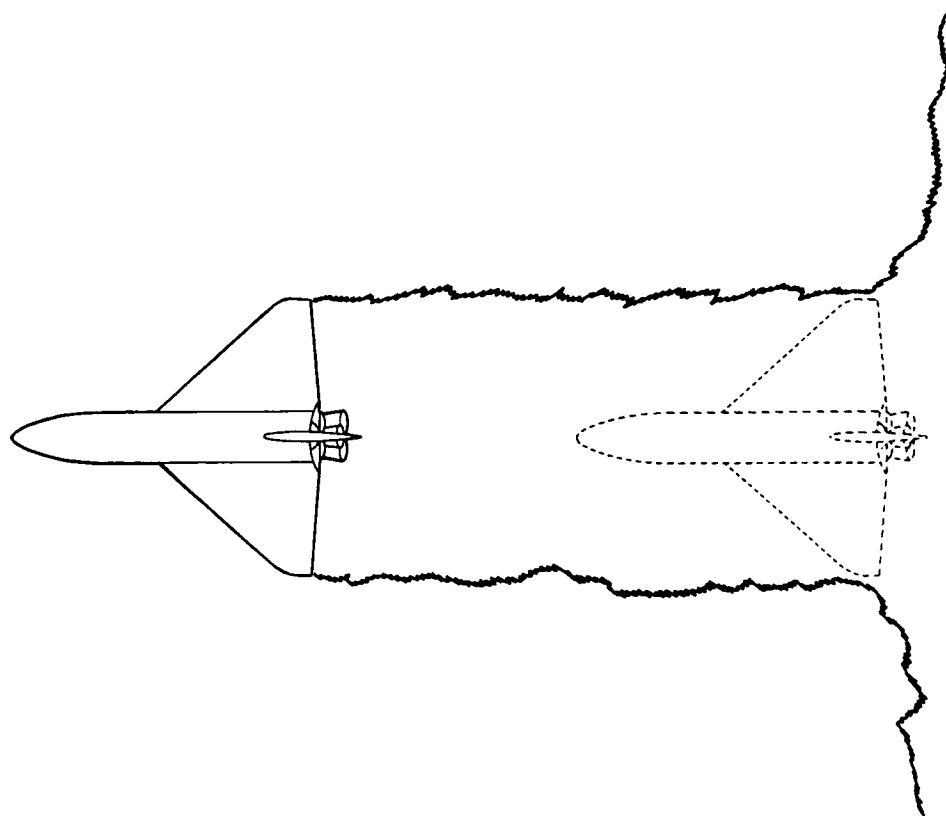
Figure 9-6. Mechanism of Stroke Hang-on

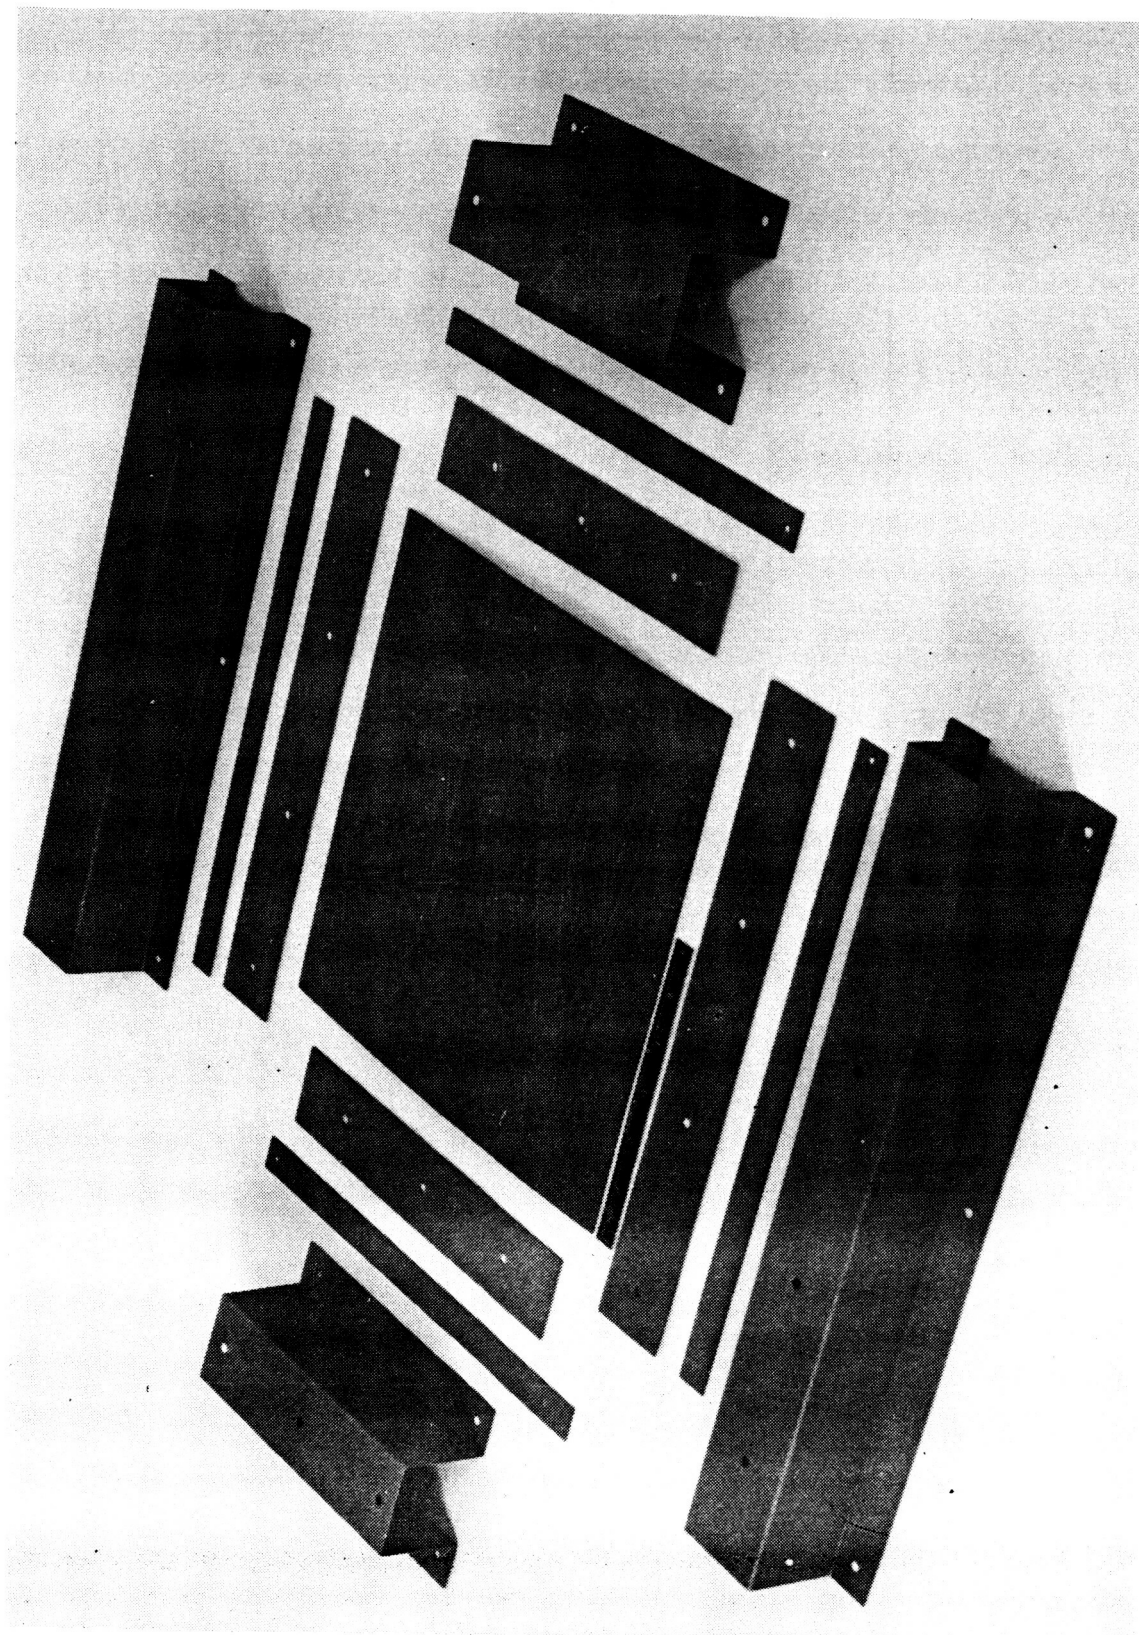
Figure 9-7. Cb-752/R-512E Lightning Strike Specimen Components
Prior to Assembly (Photo 117844B)

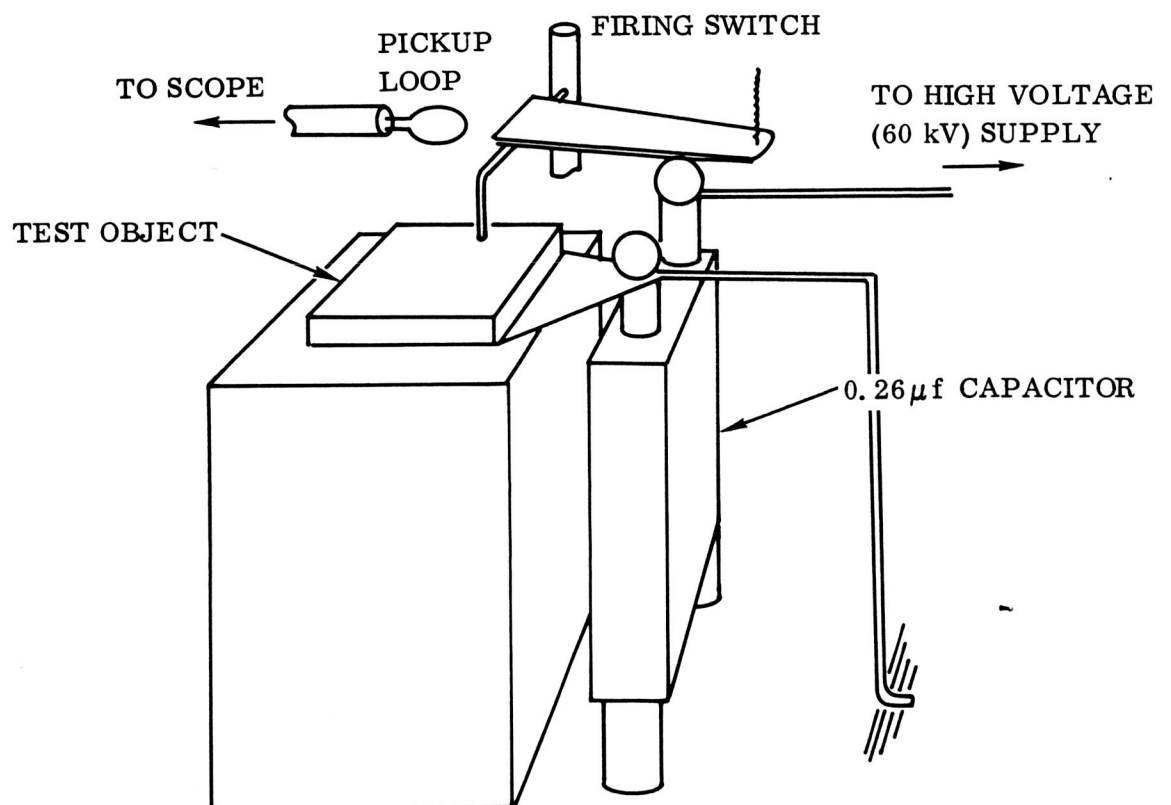
Figure 9-9. Test Arrangement for High Rate of Rise Test

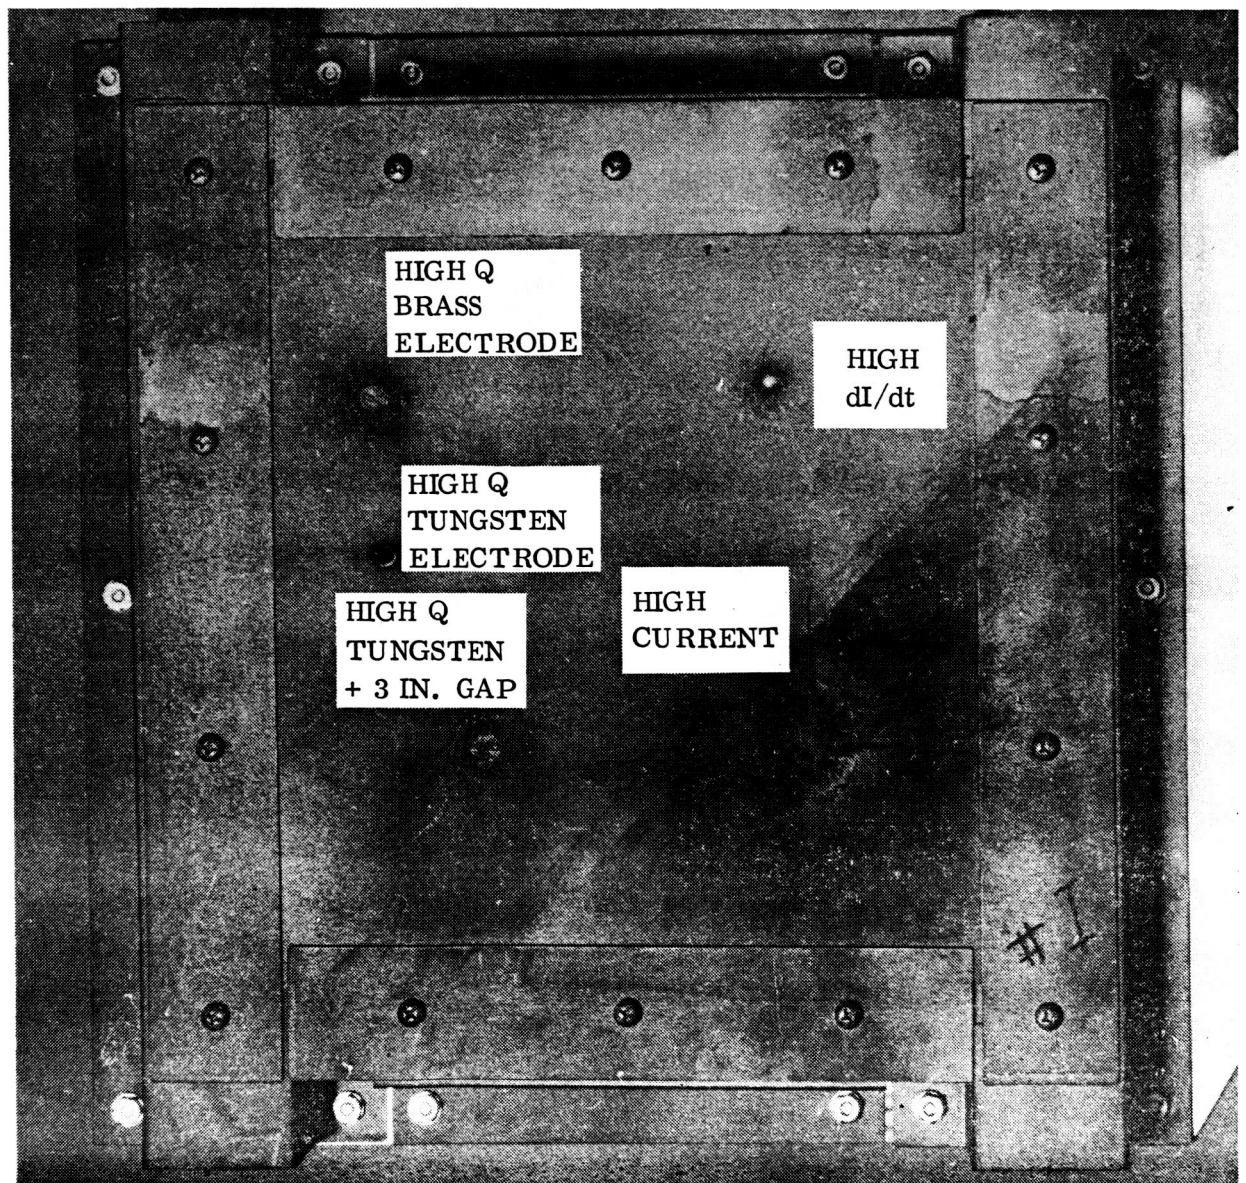
Figure 9-12. As-Coated Cb-752 Test Specimen After Lightning Strike Test Sequence

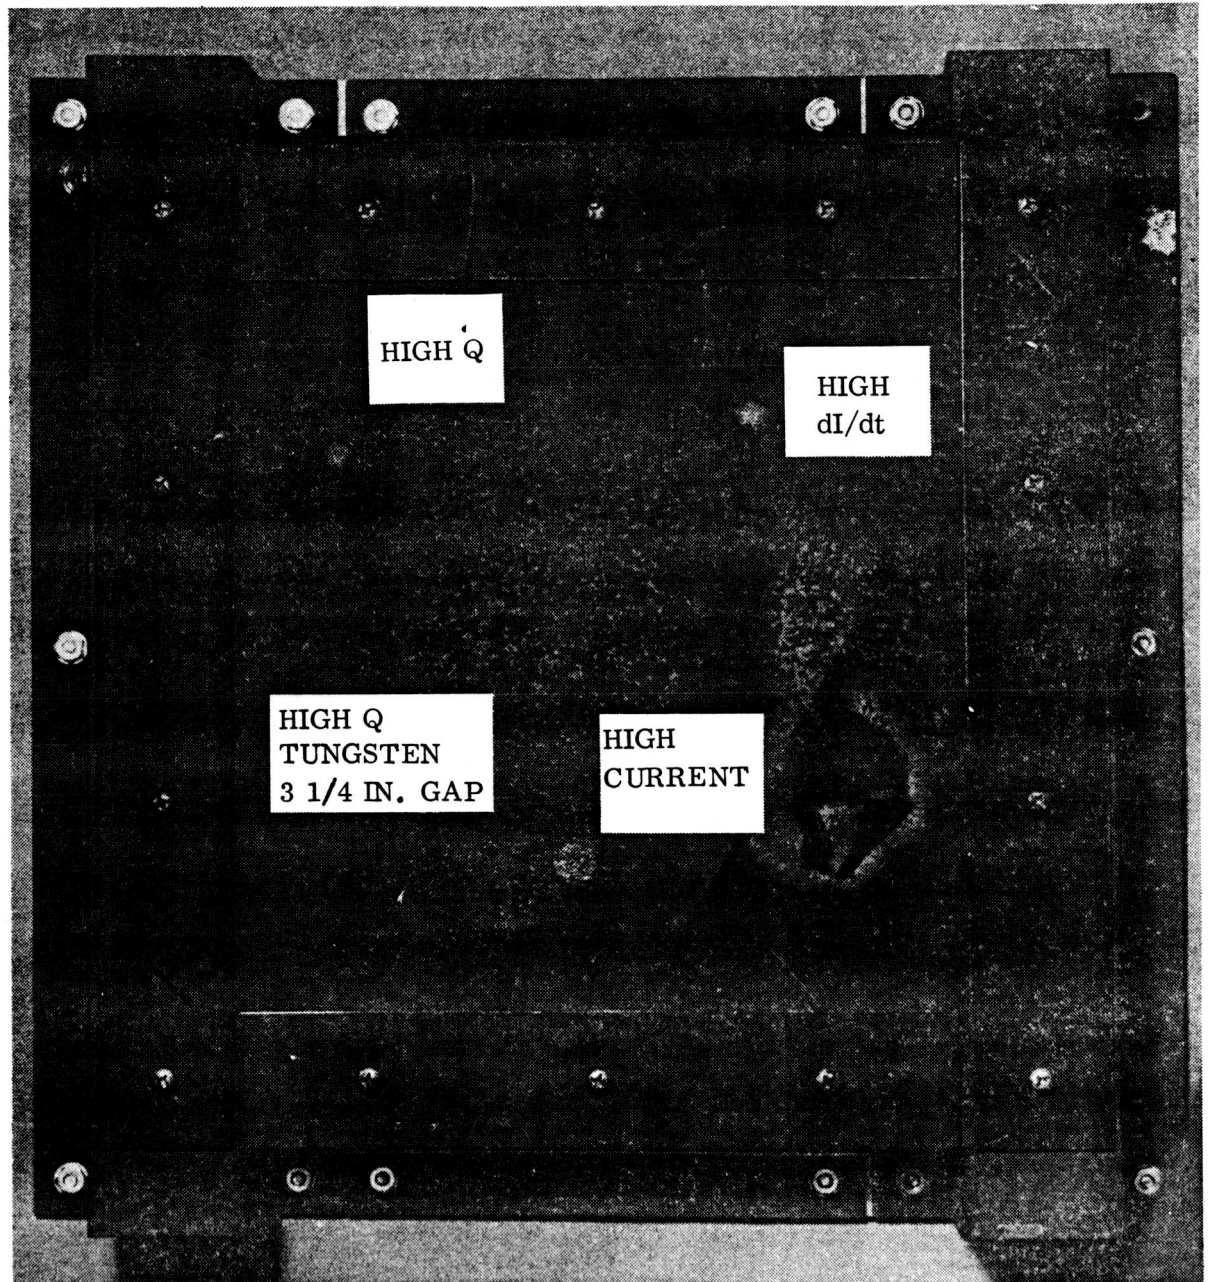
Figure 9-13. Pre-Oxidized Cb-752 Test Specimen After Lightning Strike Test Sequence

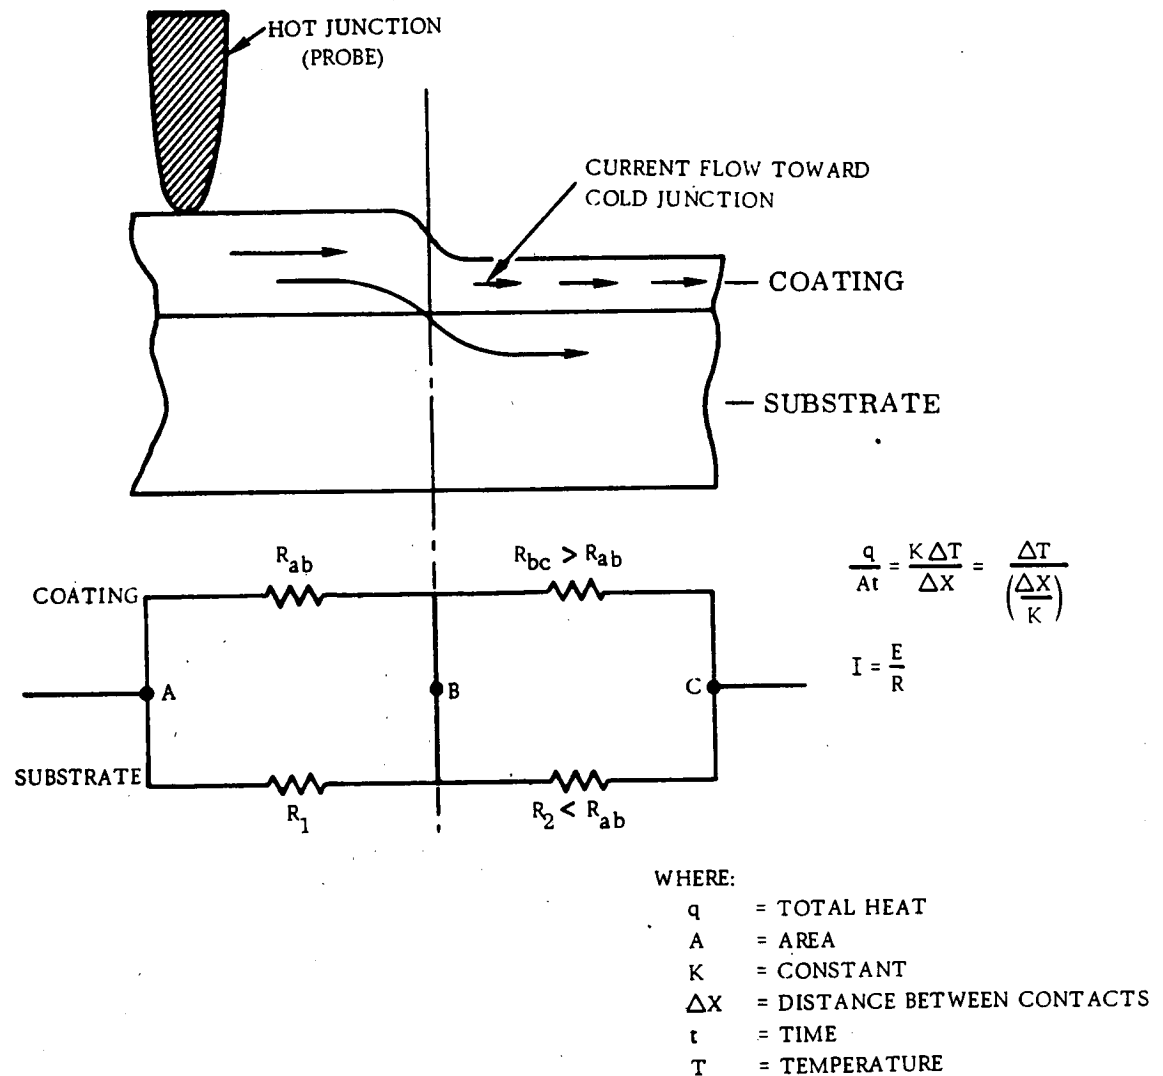
Figure B-1. Sketch Illustrating Heat Sinking Effect of Substrate and Equivalent Electrical Circuit During Thermoelectric Testing of Thin Coating

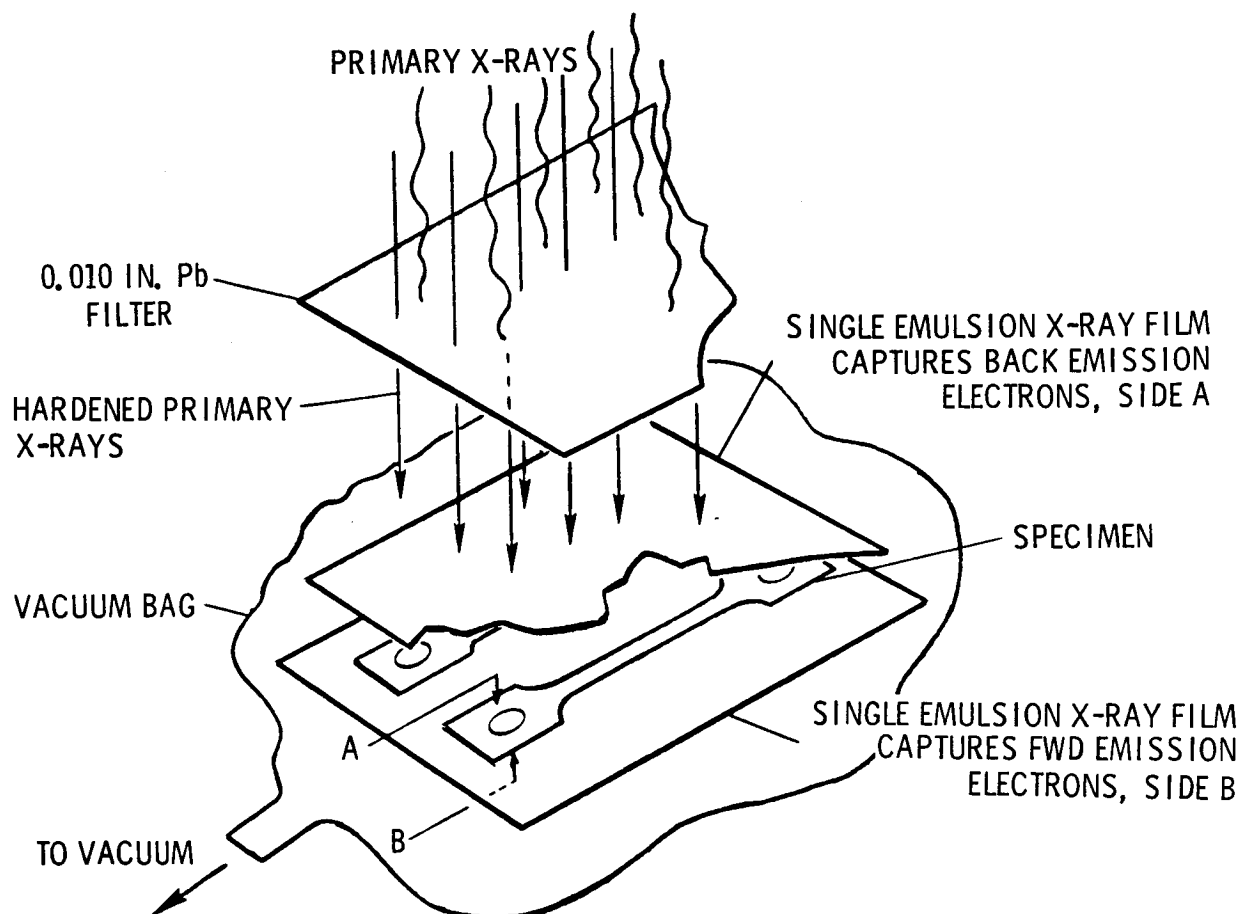
Figure B-8. Setup for Stimulated Electron-Emission Radiography

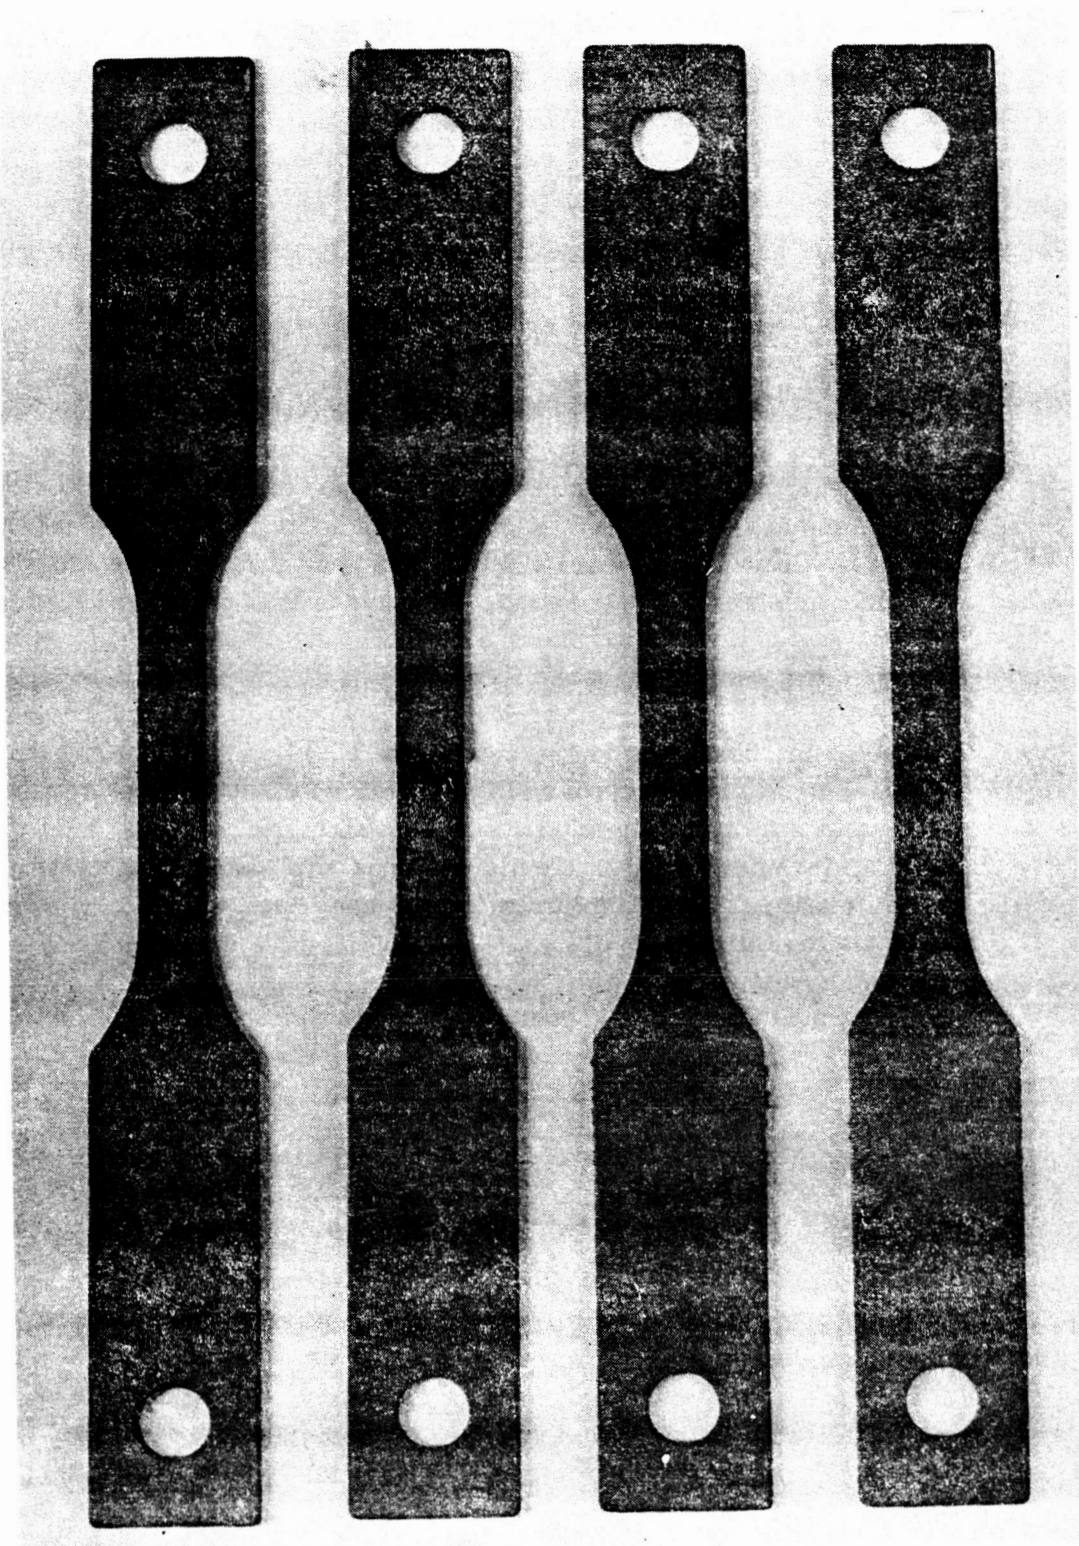
Figure D-4. Brazed Specimens [0.08 inch (0.203 cm) overlap] after 100 Flight Simulation Cycles (Photo No. 128381B)

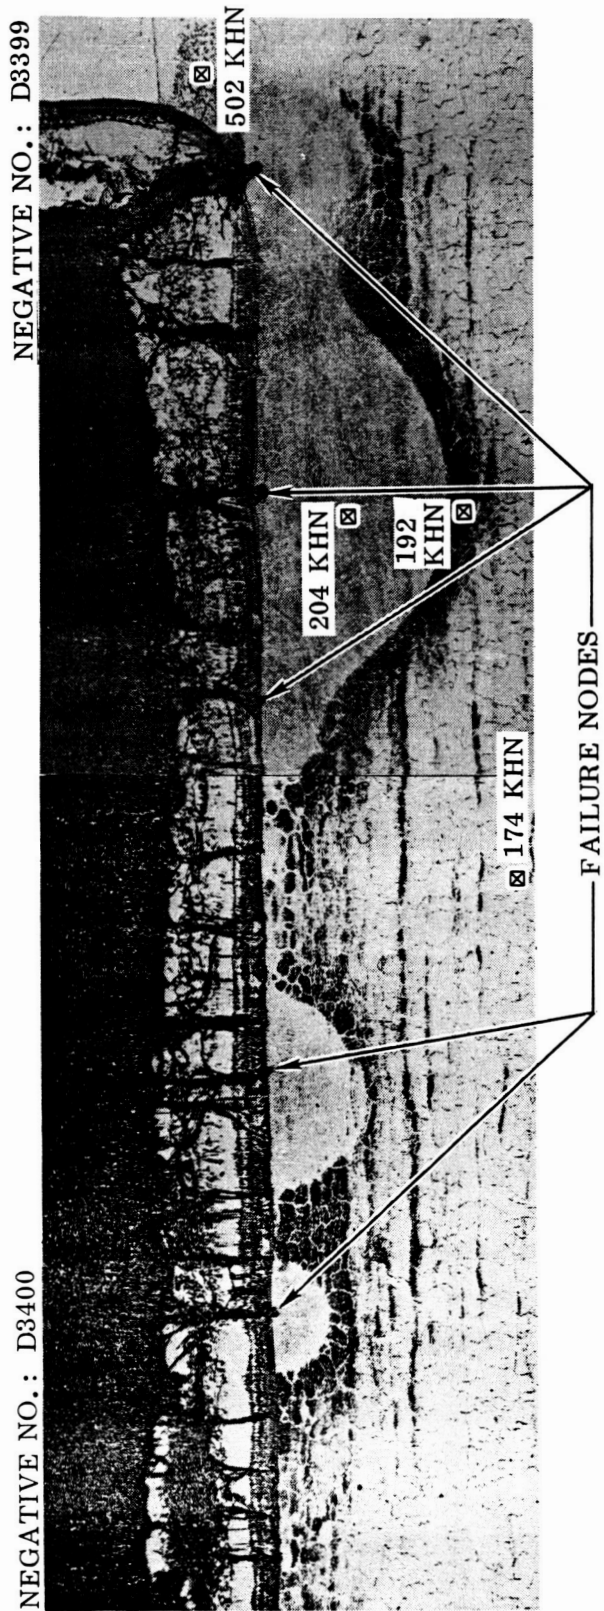
Figure D-10. Microstructure of Exposed Cb-752/R-512E Brazed Tensile Specimen

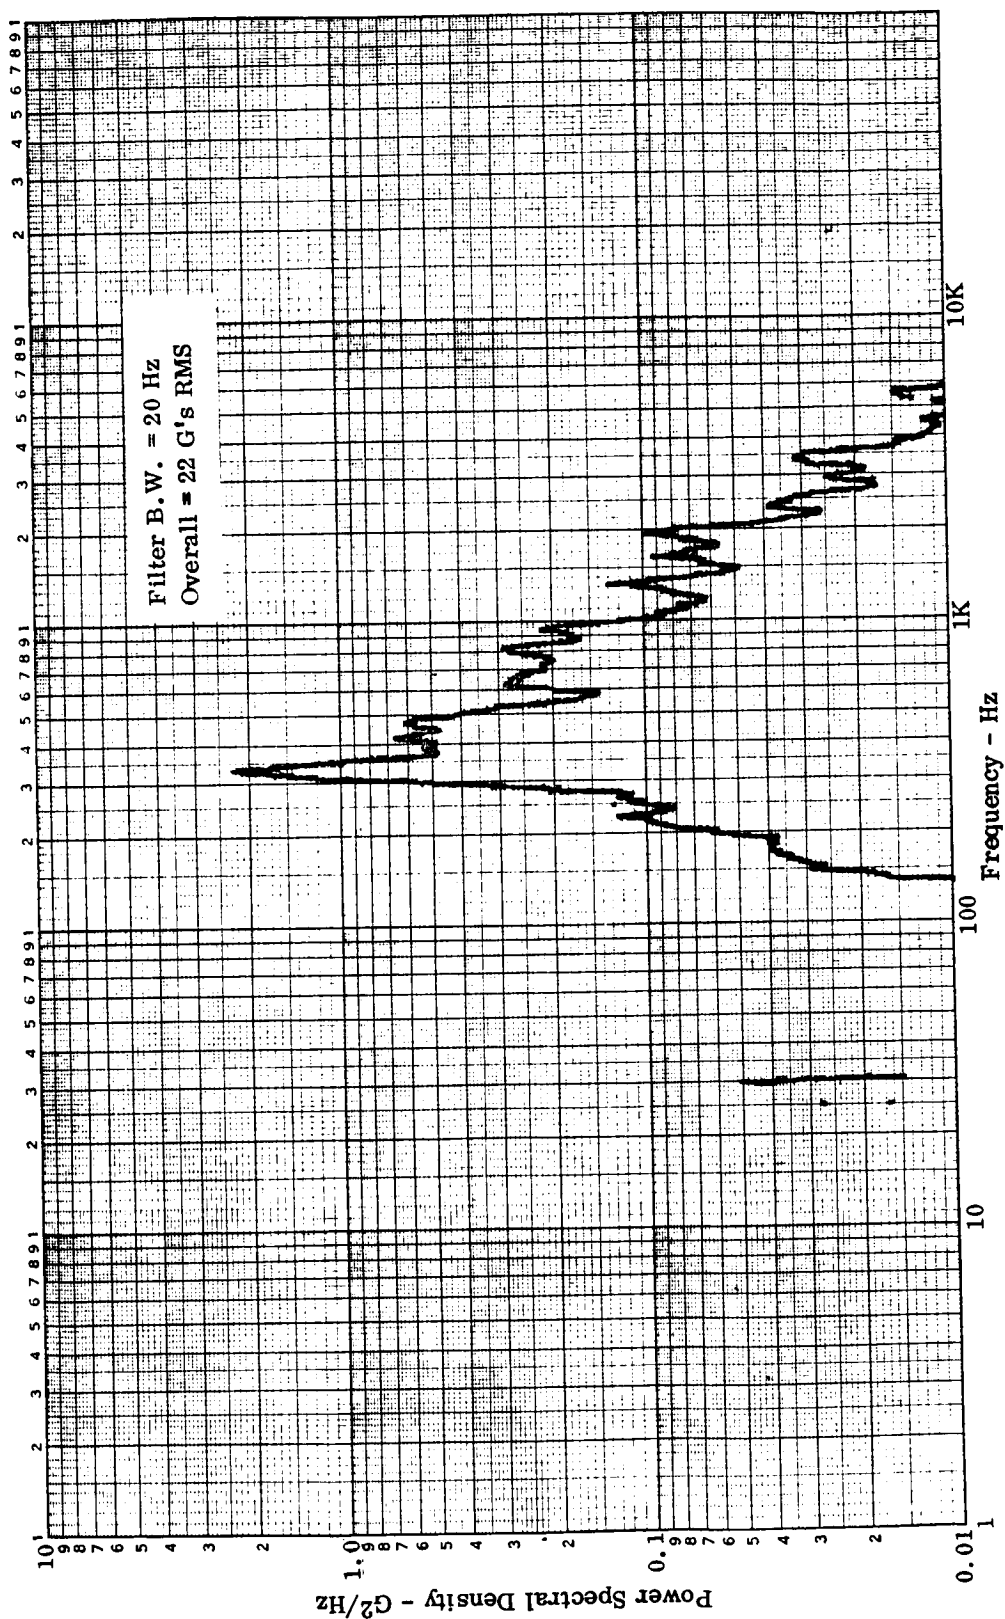
Figure E-1. Tee-Stiffened TPS, Accelerometer No. 2, 155 dB OASPL, Cycle No. 1
